Greening Bishop's Waltham

A warmer home this winter

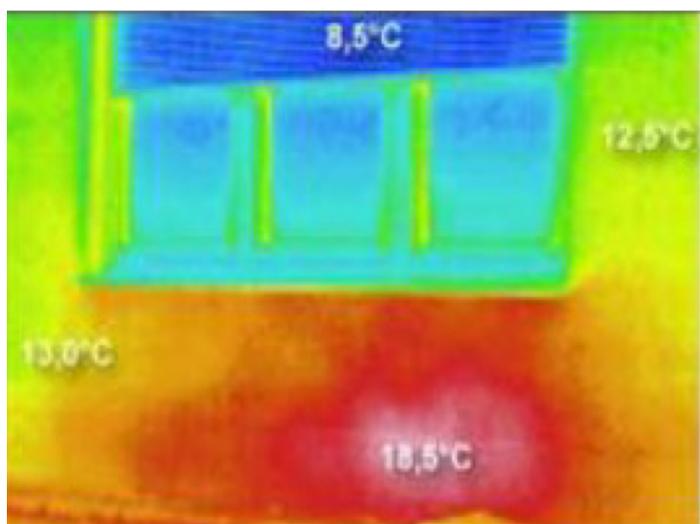
The heat from this radiator is visible through the outside wall! A simple and cheap solution would be to put a reflective heat roll behind the radiator.

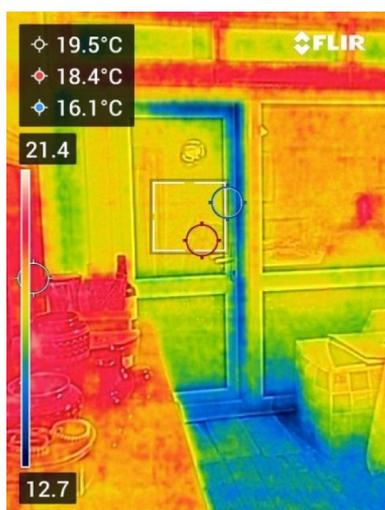
The door is double glazed, but shown in dark blue there's a draught coming in around the edges! Looks like the brushes need replacing inside the door frame – cost about £10 on-line.

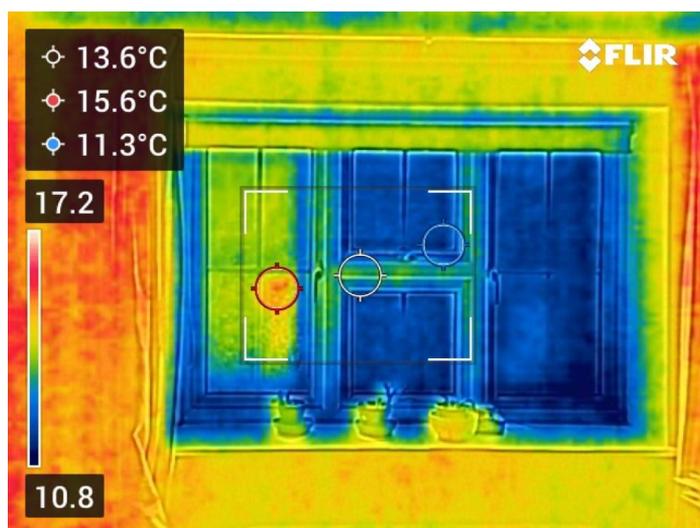
Some double glazed windows are better than others... The replacement left-hand one that is yellow / green is argon-filled and clearly more insulating (this is viewed from inside the house – so dark blue shows cold air coming in through the older windows). A thermal blind and lined curtain closed at dusk each night helps to cut this draught significantly.

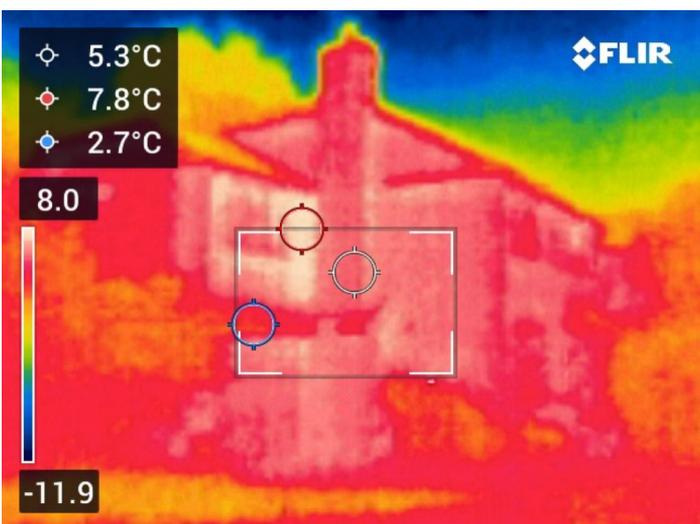
Here it seems that there's heat loss from the joint between the house and the extension. This might need the cavity wall insulation topping up.
